A strong frame is a good basis.

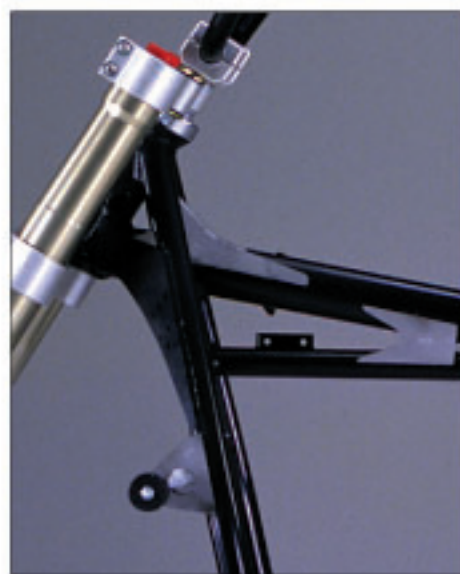
Reinforced steering head area, for better driveability and higher loads.

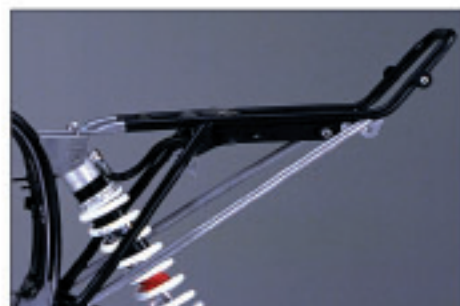
Reinforced rear section and mounting points of the shock absorber are designed for highest stresses.

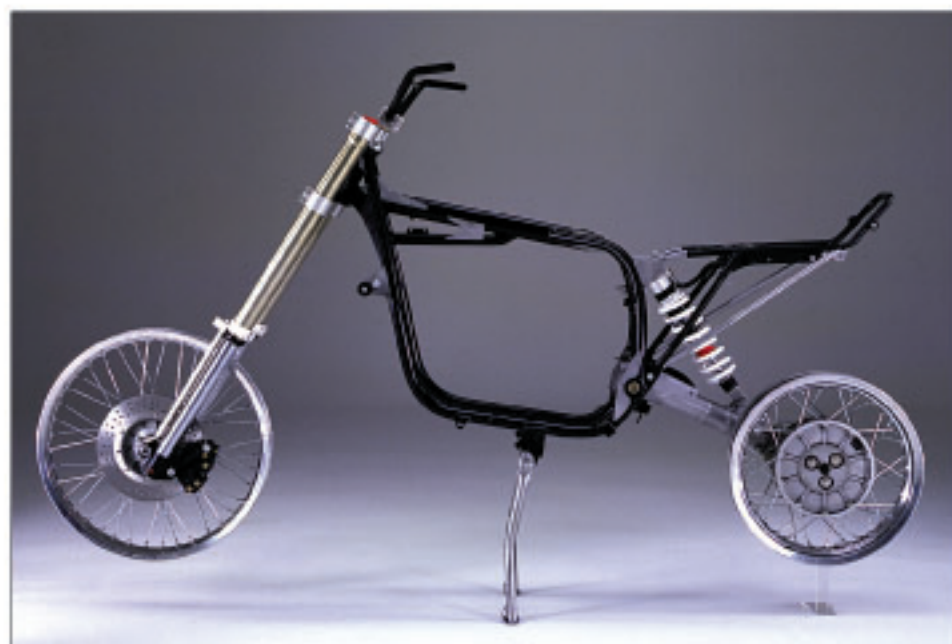
At the stripped skeleton you see the reinforcements of the frame.

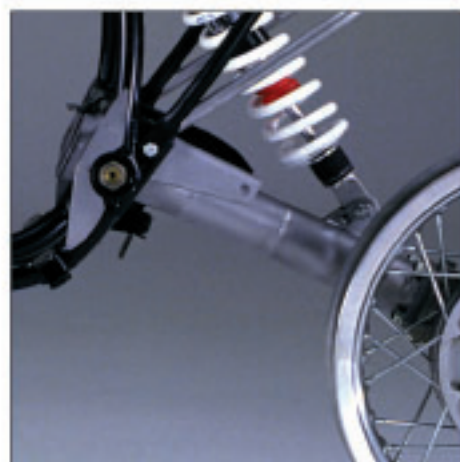
Also the swingarm area is reinforced.
